RE: Geotechnical Engineering Recommendations Letter
Slope Failure Observation and Temporary Mitigation Alternatives
Stateline Drive
Holiday Island, Arkansas
GTS Proposal No. GTS118093

Geotechnical Recommendations Letter

Slope Stability Evaluation and Slope Failure Mitigation

Stateline Drive

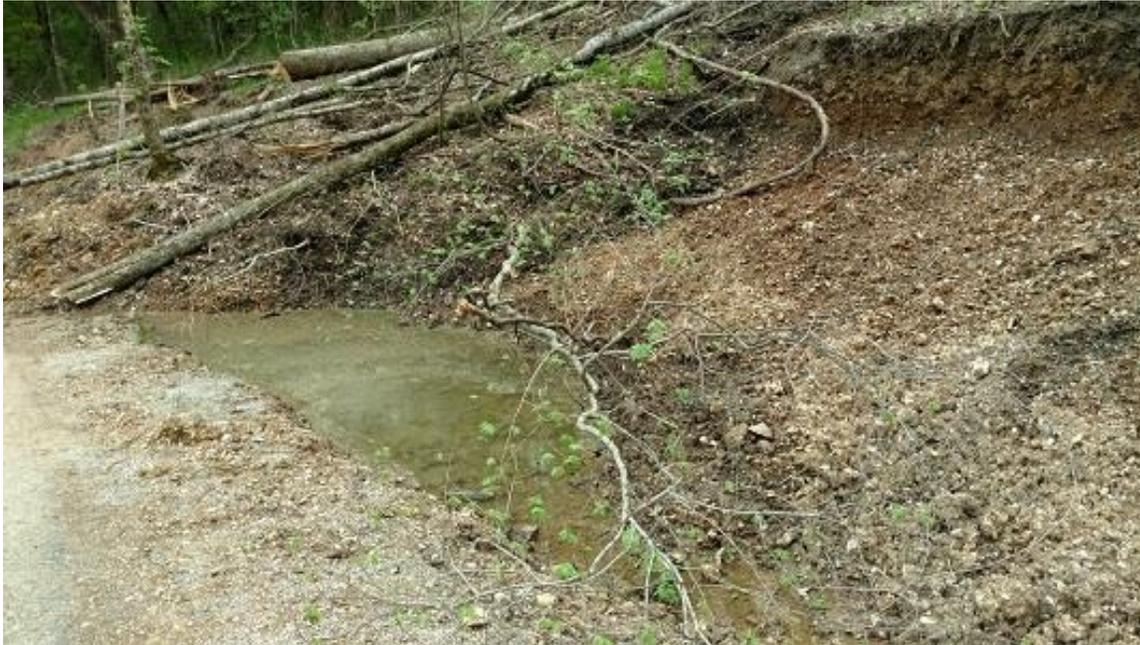
We understand that the toe of the slope recently failed in late April 2018 and the soils covered Stateline Drive (area shown in Photograph 1). The soils were removed from the road and additional soils were removed from the area adjacent to the north of the road to prevent additional material from covering the road later.

We observed the exposed soils at the toe of the slope, where the soils had been excavated and removed as part of the recent slope repairs adjacent to Stateline Road. The area where the slope failure occurred and was excavated adjacent to the roadway was approximately 50 feet wide and extended up the hill about 20 feet. The soils were removed and disposed of downhill of the road and away from the site. We observed predominantly wet, silty clayey chert gravel soils exposed in the excavation north of the road. Water was observed flowing from the base of the gravel soils and collecting in the ditch adjacent to the road. Small outcrops of limestone bedrock were exposed underneath the clayey gravel in a few areas. We understand that the earthwork contractor scraped the limestone and could not penetrate it as they were removing the soils.

Photograph 1: Slope toe of the recent slide adjacent to Stateline Road. The soils that moved into the road during the slide were excavated and removed prior to our site visit. Note that water is collecting at the base of the slope toe adjacent to the pavement.

We understand that the soils that slid into Stateline Drive were excavated and moved away from the site. Additional toe soil materials were removed to prevent them from continuing to slide into the road. To stabilize the soils upslope of the toe, we recommend replacing the excavated soils with heavier rock (rip rap). Rip rap placed at the toe should provide a mass to resist the soils sliding above the limestone and provide a drainage layer to alleviate the water flowing from the soils at the base of the toe.

We recommend removing the soils remaining in the area that has already been excavated to the top of the limestone so the rip rap can be placed directly on limestone. The soils that are presently remaining in the slope should not be removed any farther upslope. Additionally, a ditch should be excavated adjacent to the road and extending downhill to the east to promote draining water away from the slope failure area. A natural valley/creek bed appeared to be located to the east and would be an effective area to discharge the water.

Rip rap should be placed starting adjacent to the pavement and pushed/placed upslope. The rip rap should be stacked approximately two layers in thickness for interlocking and confinement.

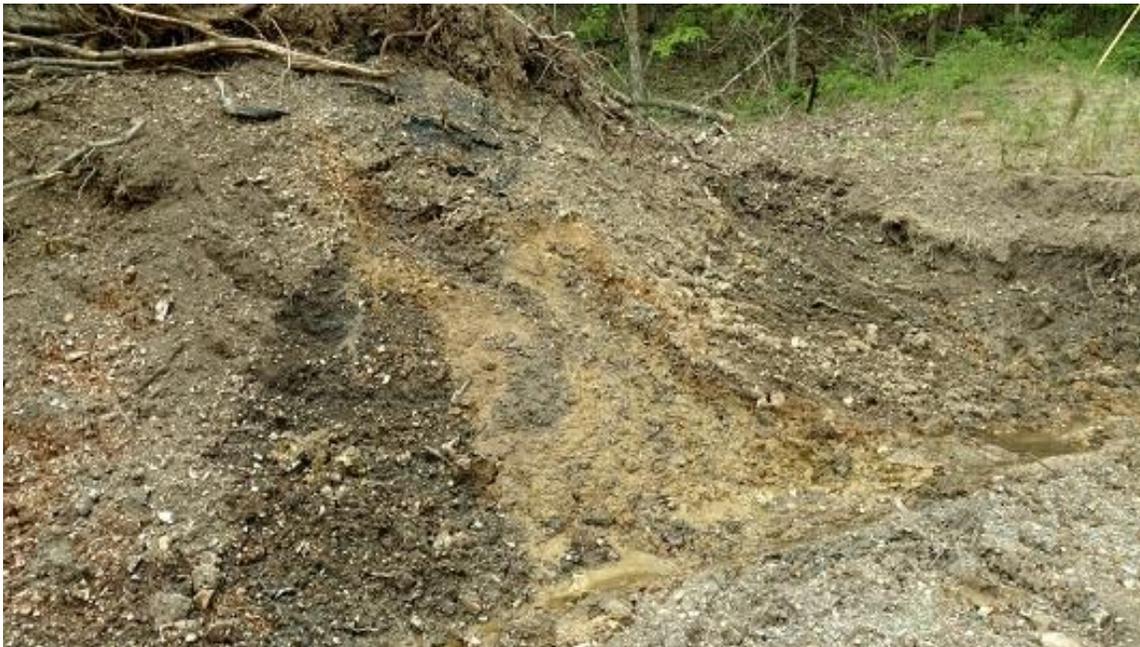
Photograph 2: The soils exposed in the slope toe after recent repairs consisted of silty clayey chert gravel. Water seeped from the soils near the bottom of the toe.

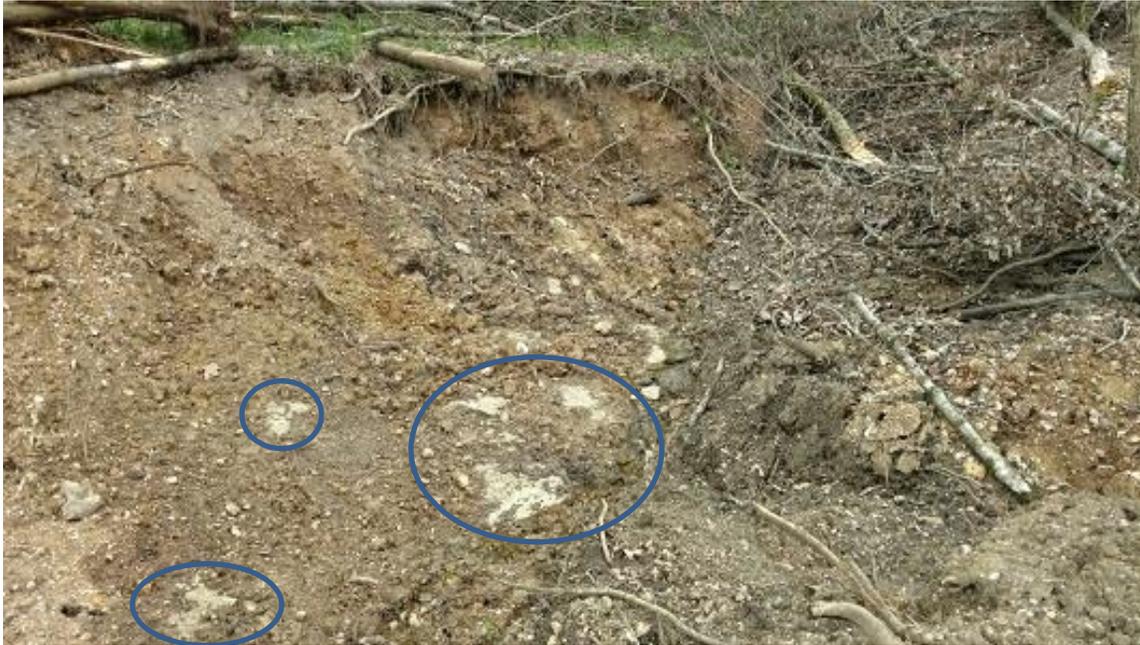
Photograph 3: Limestone bedrock exposed at the base of the slope toe excavation (shown by blue outline).

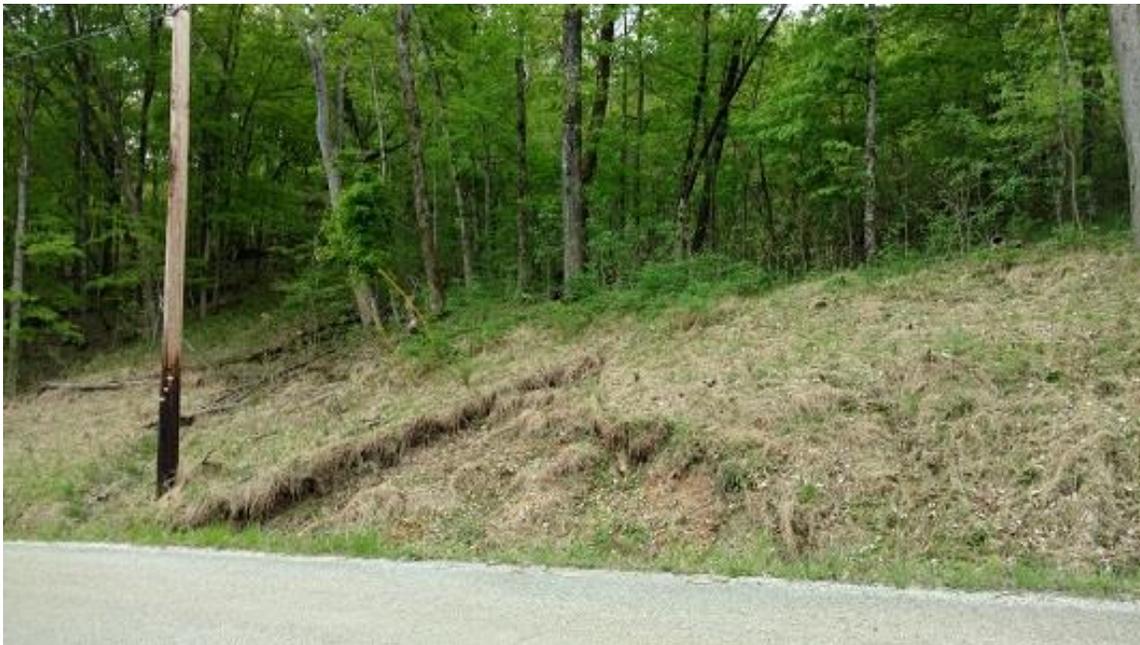
We also understand that other slope movement has occurred previously in this area. A slide occurred during March/April 2017 to the east of the recent slide after the heavy seasonal rains.

Photograph 4: Previous slope failure (slide) that occurred during April 2017, located just east of the current slide.

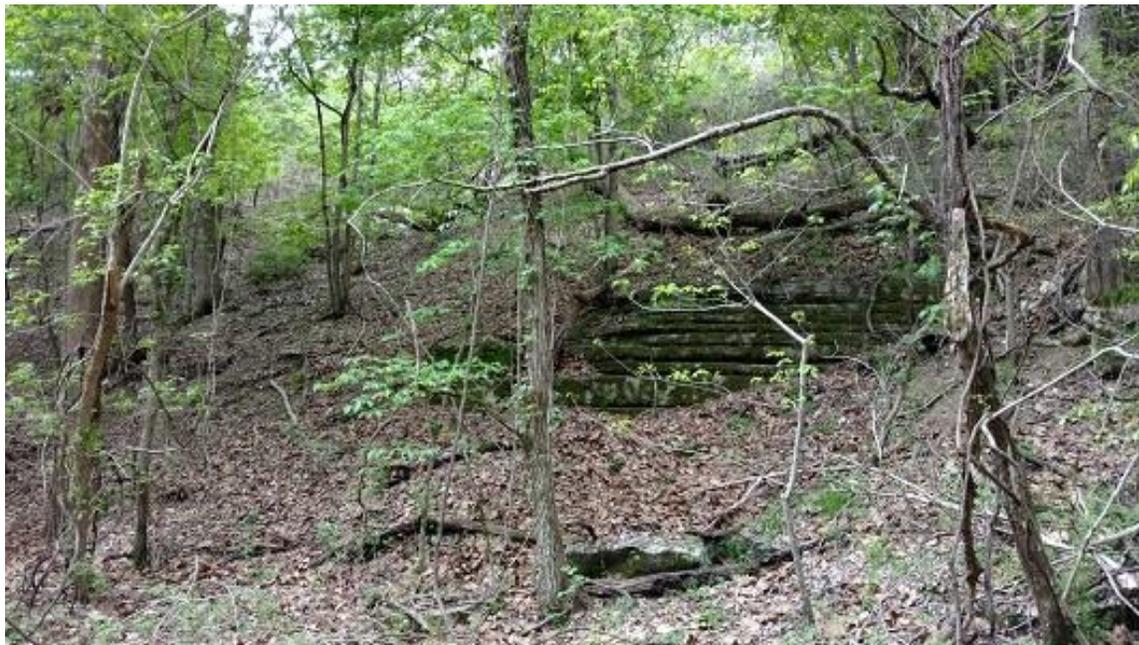
We accessed the upper portion of the slope from a residence located on Holiday Island Drive and adjacent to the west of the site. An exposed limestone bluff is present at the top of the slope. It appears that Holiday Island Drive is constructed at the top of the ridge above the limestone bluff. The limestone outcrops near the top of the slope are approximately 10 to 15 feet high where exposed.

Photograph 5: Limestone bluff exposed near the crest of the slope, downhill of Holiday Island Drive.

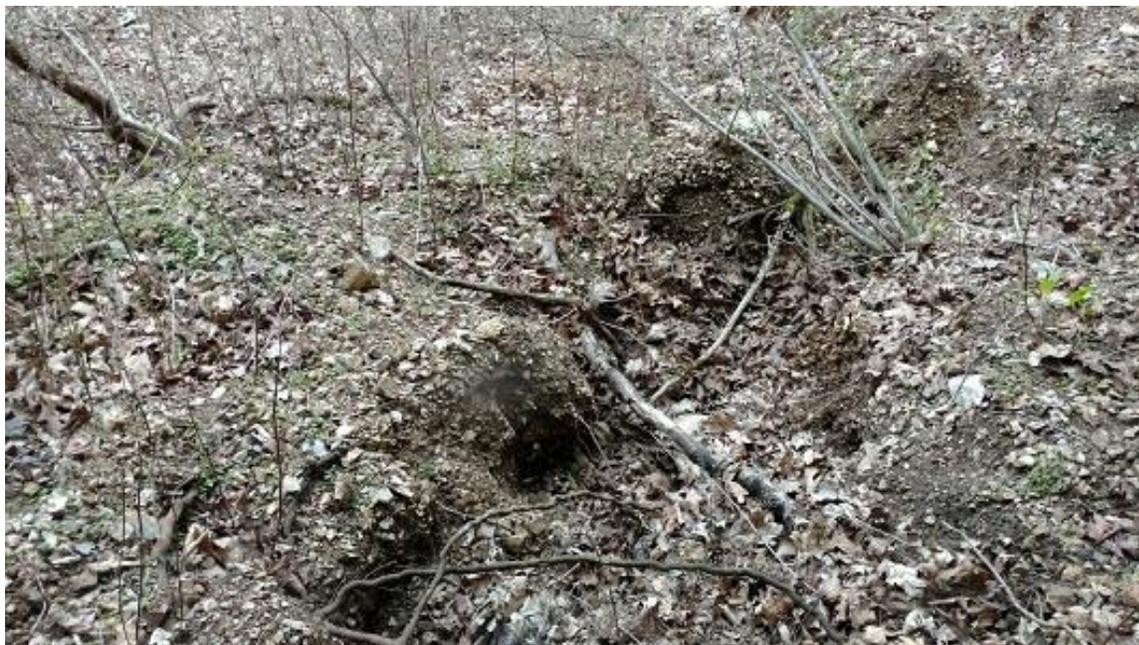
We did not observe water seepage at the base of the limestone. However, we noticed several areas where water scoured the surface of the slope, beginning at the base of the limestone bluff and in scattered areas downslope of the bluff.

Photograph 6: Scouring in the slope downhill of the limestone bluff.

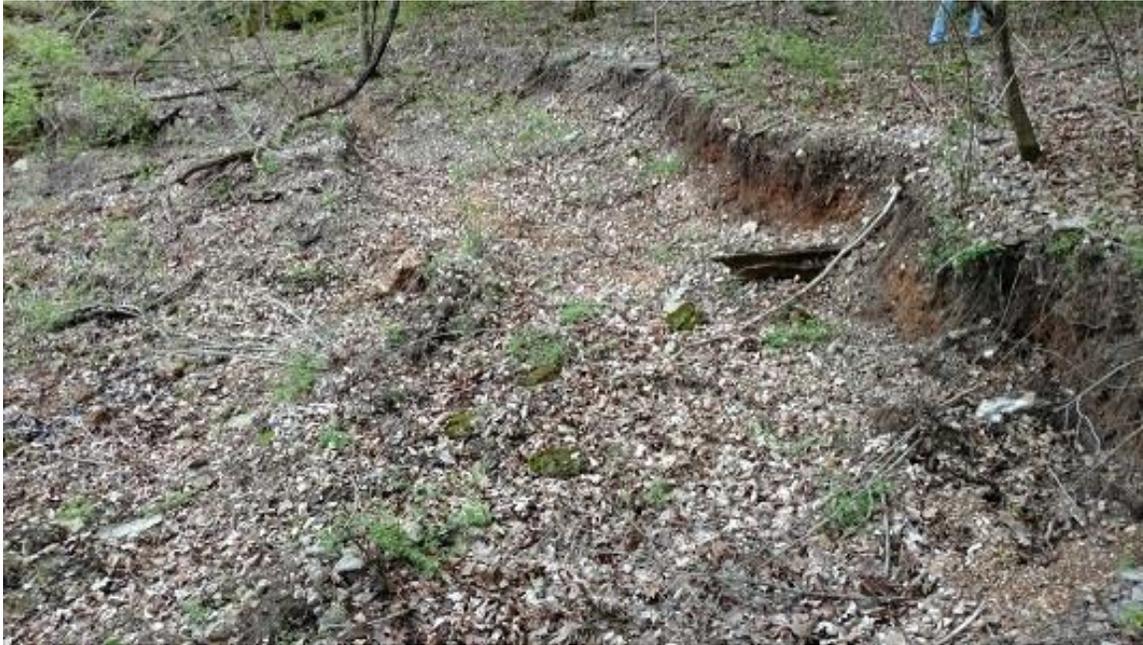
Photograph 7: Scarp located mid-slope and downhill of the limestone bluff. This scarp appeared to indicate the uphill extent of the areas subject to historic slope failures/slides.

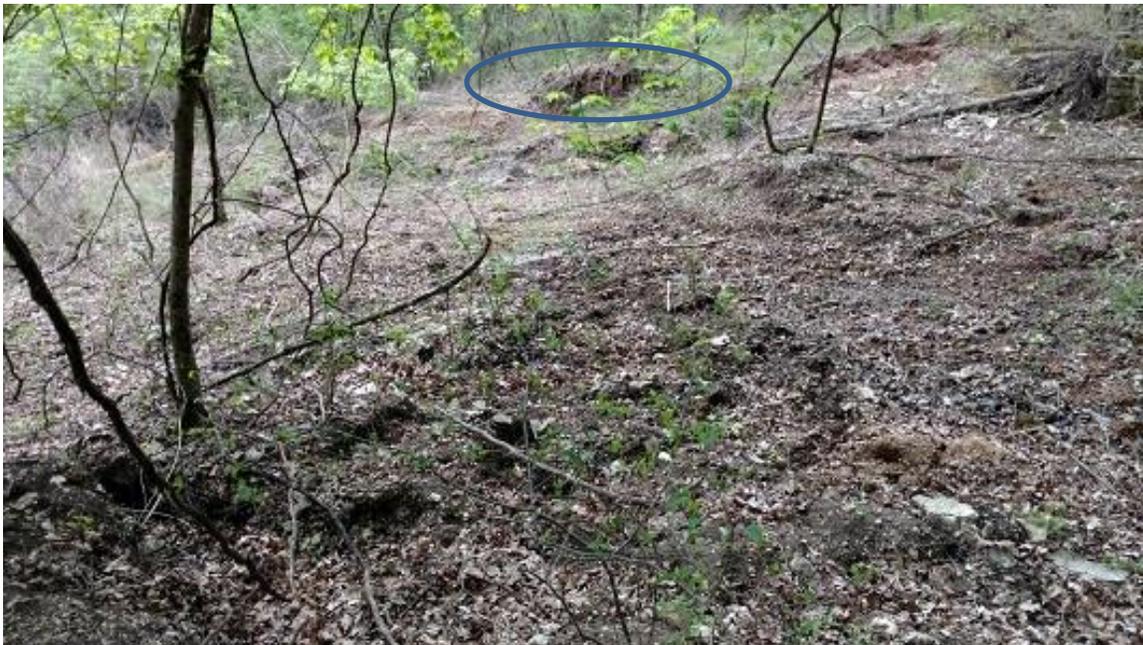
Photograph 8: The mid-slope soils are apparently prone to repetitive slides and instability. The scarp shown in the background is also shown closer in Photographs 9 and 10.

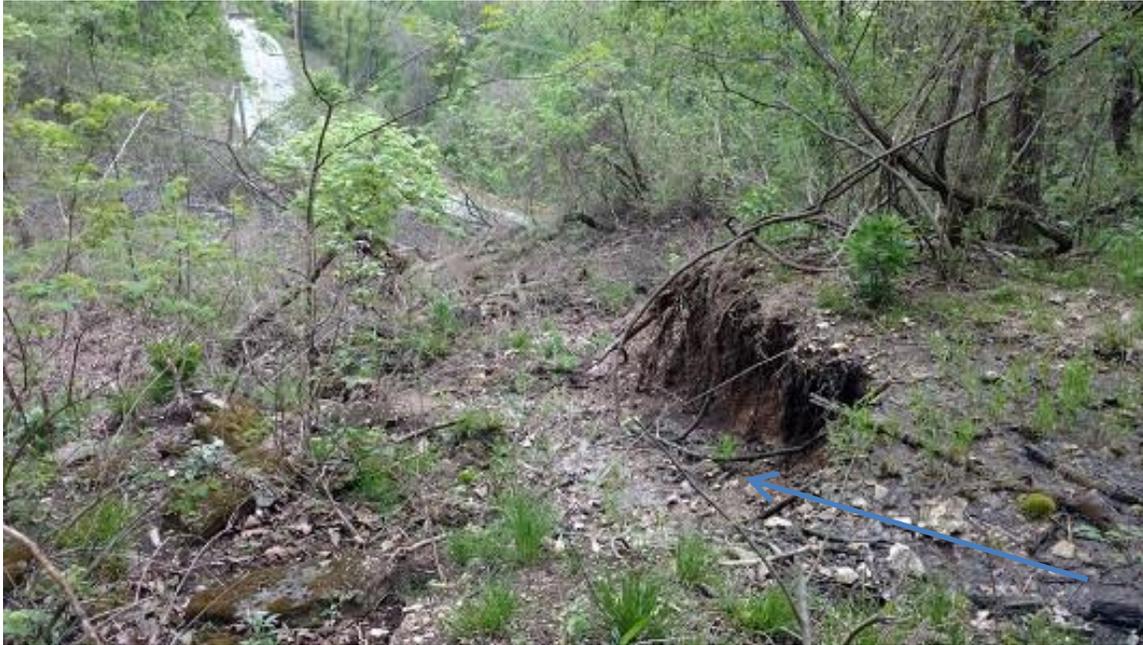
We observed at least three scarps in the middle portion of the slope. Most of the soils in the middle portion of the slope were too wet and soft to support foot traffic. As shown in Photographs 9 and 10, we observed water flowing over the ground surface and draining into the main slide area. The scarp exposed brown silty clayey chert gravel soils underneath an approximate 1-foot thick layer of dark gray, organic-rich silty gravel. Most of the trees and brush in the middle portion of the slope were undermined and toppled.

Photograph 9: Eastern scarp located approximately mid-slope. Water was flowing on the ground surface (in the lower right-hand corner of photograph) and drained into the area of the unstable soils above the slope toe failure.

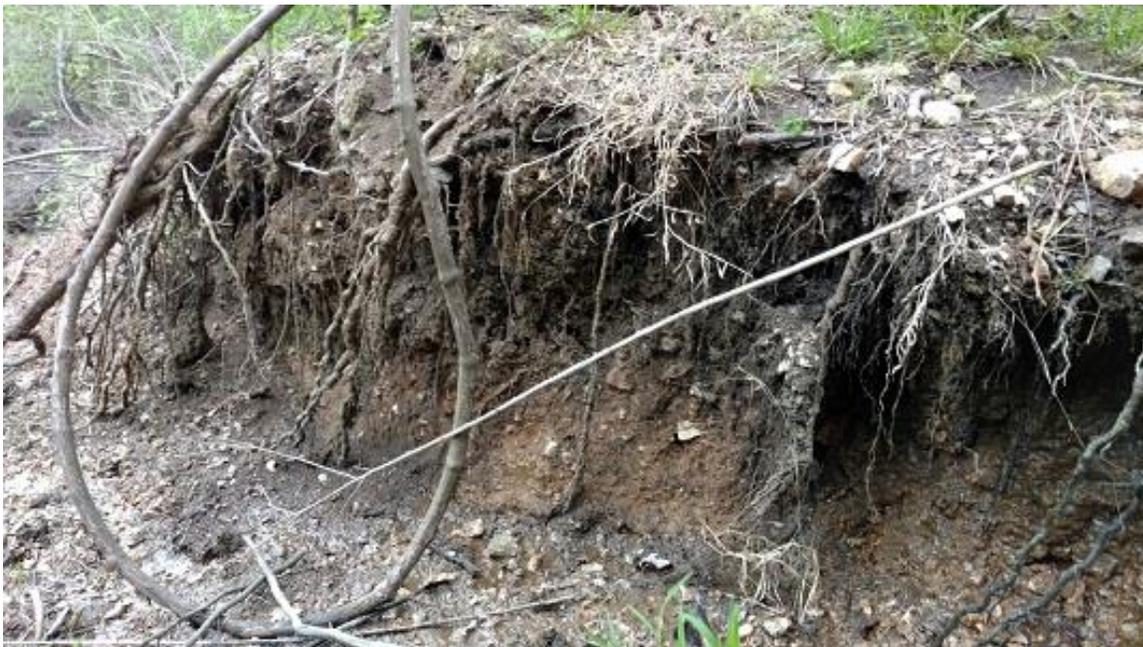
Photograph 10: Closer view of the saturated soils in the scarp. The soils predominantly consisted of dark gray, organic-rich silty gravel overlying brown silty clayey chert gravel.
